Seismic damage of highway bridges during the 2008 Wenchuan earthquake

Abstract: Many highway bridges were severely damaged or completely collapsed during the 2008 Wenchuan earthquake. A field investigation was carried out in the strongly affected areas and over 320 bridges were examined. Damage to some representative highway bridges is briefly described and a preliminary analysis of the probable causes of the damage is presented in this paper. The most common damage included shear-flexural failure of the pier columns, expansion joint failure, shear key failure, and girder sliding in the transversal or longitudinal directions due to weak connections between girder and bearings. Lessons learned from this earthquake are described and recommendations related to the design of curved and skewed bridges, design of bearings and devices to prevent girder collapse, and ductility of bridge piers are presented. Suggestions for future seismic design and retrofitting techniques for bridges in moderate to severe earthquake areas are also proposed.

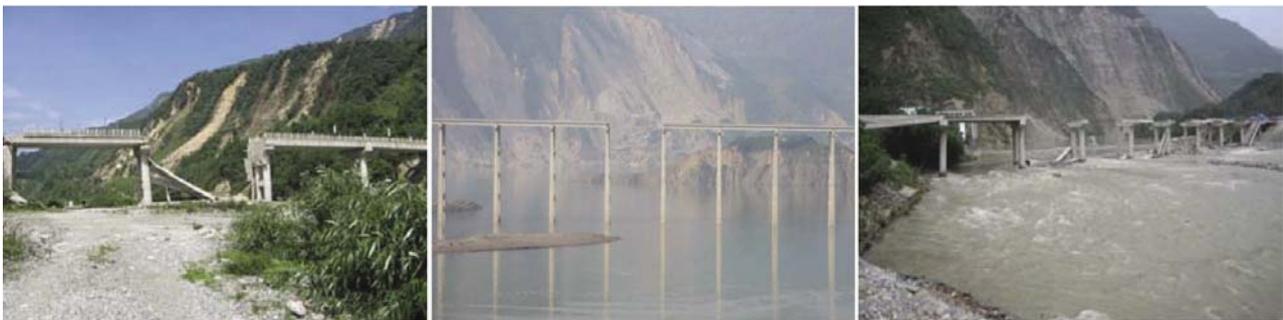
Span failure was caused by unseating, which included pier tilting, insufficient seat width, and/or inadequate restraining force capacity. The relative movement was amplified if the motions of the adjacent piers were in the opposite directions. Figure 1(a) shows the collapse of the main girders of the Gaoyuan Bridge located at Hongkou, Dujiangyan City and Fig. 1(b) shows a similar case that occurred in the Miaoziping Bridge on the Duwen Highway. This bridge consisted of three-span continuous rigid frames and approach spans composed of 19×50 m spans simply supported girder with continuous bridge deck. The height of the pier columns exceeded 100 m. The collapse of the main girder was most likely caused by ground acceleration amplification due to the relatively flexible piers and large mass of the bridge deck, resulting in large inertia forces and considerable translational and rotational motions of the girders during the earthquake. The girder fell down after the shear key failed under the impact of the girder. Figure 1(c) shows the Naba Bridge of Pinwu County, which also suffered similar failure.

It was found that many collapsed bridges either had insufficient seat width or were located directly near a major fault rupture. The near-field effect was an essential cause of these failures. Most multispan simply-supported girder bridges have shorter fundamental periods (such as the Gaoyuan Bridge, Nanba Bridge and Longwei Bridge, whose fundamental periods were less than 1 s). Compared to far-field ground motions, there was significantly more displacement amplification for short-period inelastic bridges in the near field.

(a) Gaoyuan Bridge (VII/IX)

(b) Miaoziping Bridge (VII/IX)

(c) Nanba Bridge (VII/IX)

Fig.1 Girder failure of RC girder bridges (Note: for “A/B” in parenthesis, “A” denotes the specified intensity and “B” denotes the estimated intensity during the quake, and the same holds below)

Note that in both the China Specifications/Guidelines, the influence of the seismic performance category, substructure height and angle of skew, etc., were not explicitly considered. For bridges with $L = 40$ m, both Eqs. (1) and (2) provide the same minimum seat width of $a = 90$ cm. In fact, the specification in Eq. (2) was given by the 1996 Japanese seismic design specifications of highway bridges revised in 1996 reflecting the destructive damage caused by the 1995 Hyogo-ken Nanbu earthquake (i.e., the Kobe earthquake) (Kawashima, 1997). Note that in addition to providing sufficient seat width and elastic padding between two adjacent girders to prevent failures of this type, it is recommended that strong hinge restraints be

used to restrain relative motions in the longitudinal direction.

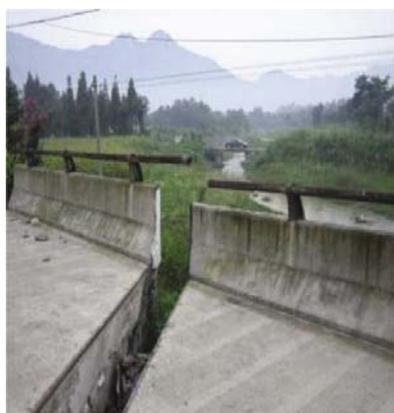
Seismic waves may cause differential movement between the super- and substructures. Large differential movements may cause span failure due to unseating. Even with small differential movements, expansion joints may be either pushed against each other, causing a compression type of failure, or pulled apart, causing a tensile failure. In general, seismic deflections may be severely underestimated for structures located in near-field areas. Damage to superstructures was mostly due to pounding of adjacent segments at expansion joints. Expansion joints were commonly used to relieve the structural system from the internal forces generated by the change of environmental temperature. They were also the weak parts of the system and were easily damaged by large, instant or permanent deformation of the foundation. Figure 3 shows damage to expansion joints observed in this event.

(a) Mawei River Bridge (VII/IX)

Fig. 3 Permanent deformations at expansions joints of bridges throughout the affected region

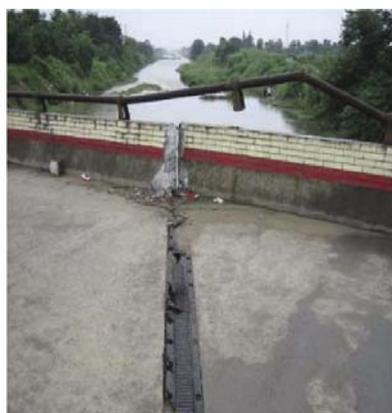
(b) Lujiaoyan Bridge (VII/IX)

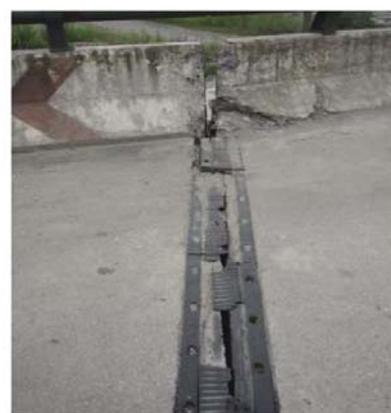
(c) Mianyuan River Bridge (VII/VIII)

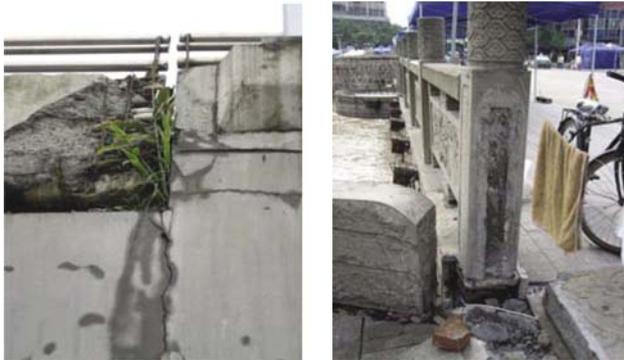
The impact damage occurred as a result of underestimating the maximum relative displacement between adjacent members. Figure 4(a) shows the impact damage to a viaduct in Mianzhu City. Damage of this type was more obvious in skew bridges, as the centerline of a skewed bridge is not perpendicular to the centerline of its piers. The collision of the deck with the abutment pier may induce rotations of the deck in the horizontal plane. The rotation of the deck may accumulate as the cyclic ground excitation continues. If the accumulated rotation is large enough, the bridge deck may lose support at corners with acute angles or even collapse. The rotation may also induce damage to the deck at corners with blunt angles as shown in Fig. 4 (b).

(a) Jinguan Viaduct
(VII/IX)(b) Xinding Skewed Bridge
(VII/IX)**Fig. 4 Impact damage to bridge superstructure**

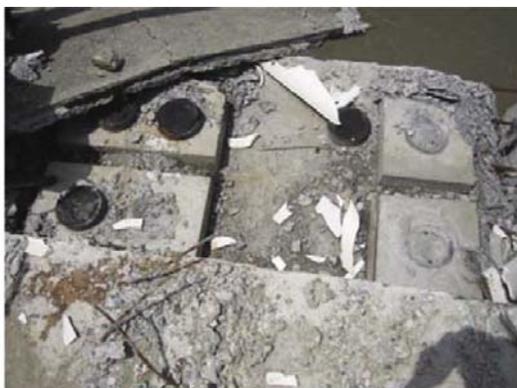
Bearings, especially seismic isolation bearings, can protect the superstructure from damage by reducing its response to earthquake excitation. However, it was found that improperly installed bearings may instead cause more damage. Figures 5(a) and 5(b) show the failure of the bearings in the Longwei Bridge in Beichuan

County and the Yinxu Minjiang Bridge, respectively. The failure was due to a lack of connections between the rubber bearings and adjacent components of the bridge structure. The bearings, therefore, are in a “floating” condition and cannot withstand the lateral or longitudinal relative movement between the pier cap and the deck, resulting in collapse of the deck. Figure 5(c) shows the shear failure of the bearing of Huilan Bridge in Mianzhu City. Figure 5(d) shows the maximum unrecoverable deformation of 15 cm of the bearing on the same bridge.

(a) Longwei Bridge (VII/XI)

Fig. 5 Bridge bearings damage in Wenchuan earthquake

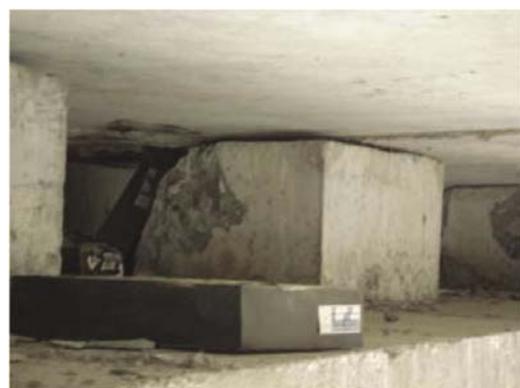
(b) Yinxu Minjiang Bridge (VII/X)

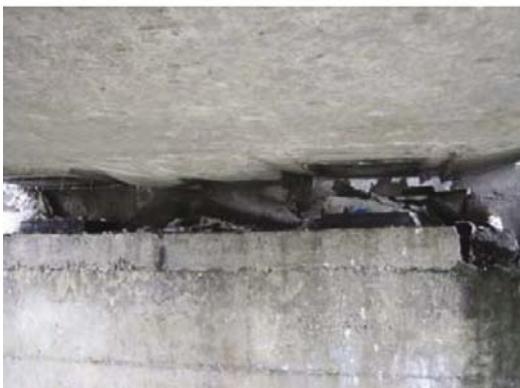
(c) Huilan viaduct (VII/IX)

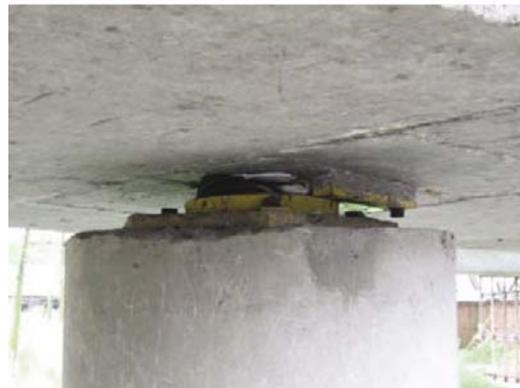
(d) Huilan ramp Bridge (VII/IX)

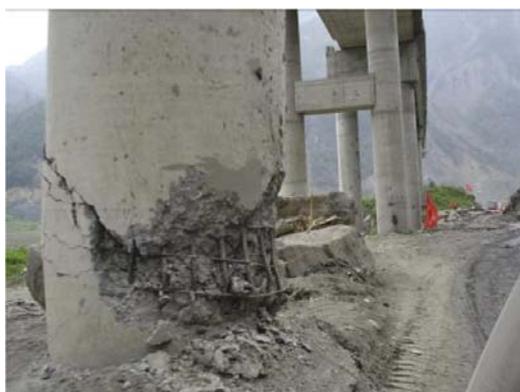
The failure modes of RC pier columns observed in this survey can be divided into two categories, i.e., bending failure and bending-shear brittle damage. Figure 6 shows a pair of pier columns that have lost their concrete protective layers due to cyclic bending moment, indicating insufficient bending capacity. Figure 7 shows a pier column of the Jueyuan Bridge, which suffered bending-shear brittle damage at its middle height, leading to a crack throughout the entire section of the pier column. Another four spans of the bridge totally collapsed due to column bending failure.

Fig. 6 Bending damage of pier of Baihua Bridge (VII/XI)

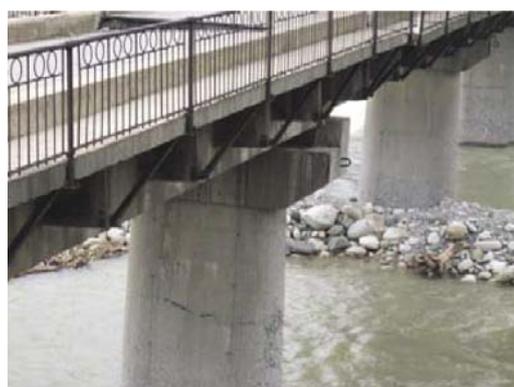
Fig. 7 Bending-shear damage of pier of Jueyuan Bridge (VII/X)

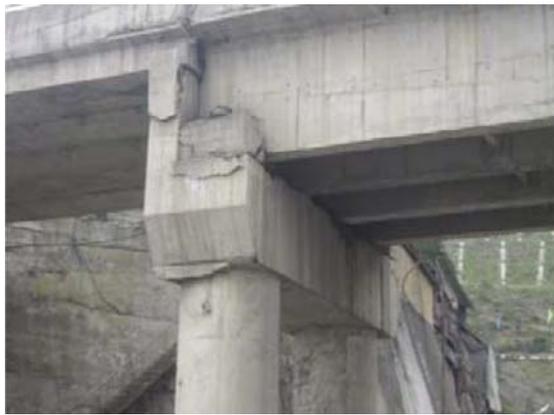
Damage to retaining block/shear key is another common mode of damage to bridges in this earthquake. Figure 8(a) shows the damage to the retaining block at a position where the superstructure changed from T-beams to plates. The retaining blocks in Figs. 8(c) and 8(d) are 15 cm wide and were reinforced with 6 Φ 14 rebar. It is clear that these blocks did not have enough strength and reinforcement to resist lateral force. Therefore, it is important that retaining blocks/shear keys be strong, ductile, and wide enough to resist the imposed force and prevent the beams from falling.

(a) A viaduct in Duwen Highway (VII/IX)

Fig. 8 Bridge retaining block failure

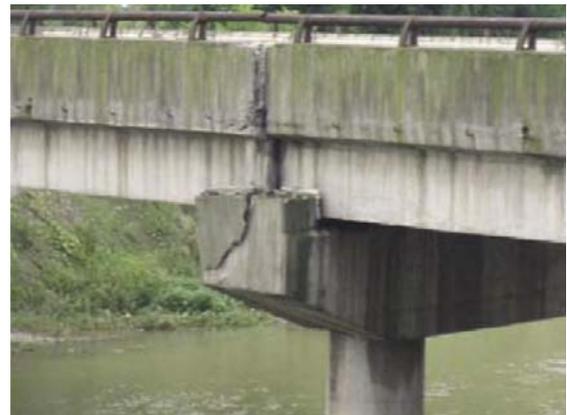
(b) Lujiaoyan Bridge (VII/IX)

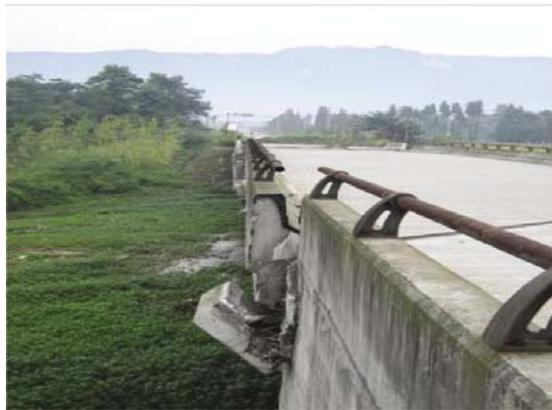
(c) Mawei River on Wuxin Road (VII/IX)

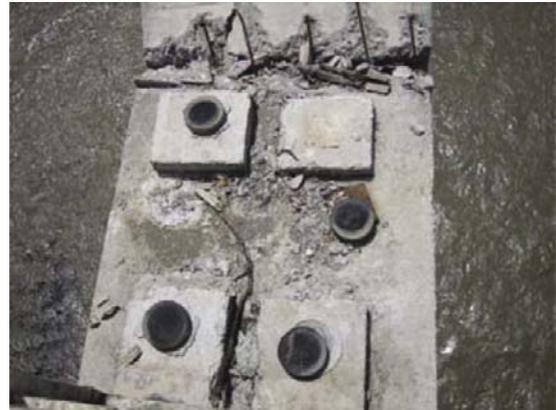
(d) Lonwei Bridge (VII/XI)

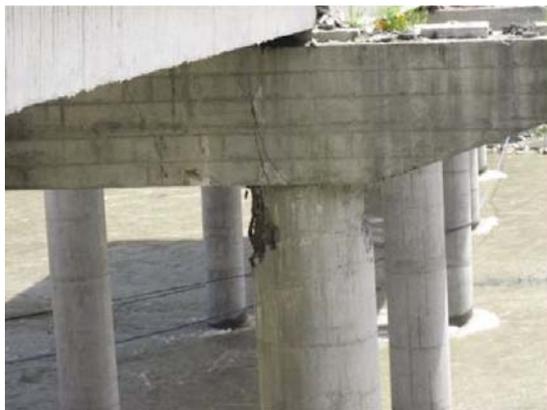
As shown in Fig. 9, the beam cap of the Longwei Bridge was cracked by a combined effect of gravity and earthquake related inertia forces. The crack initiated from the connection zone between the beam and the cap, and penetrated throughout the entire transversal beam almost vertically as a result of strong shear force induced by the earthquake. The crack width was as large as 6 mm, implying insufficient shear reinforcement. Figure 10 shows juncture damage of the Beihua Bridge,

**Fig. 9 Beam cap cracking of Longwei Bridge (VII/XI)**

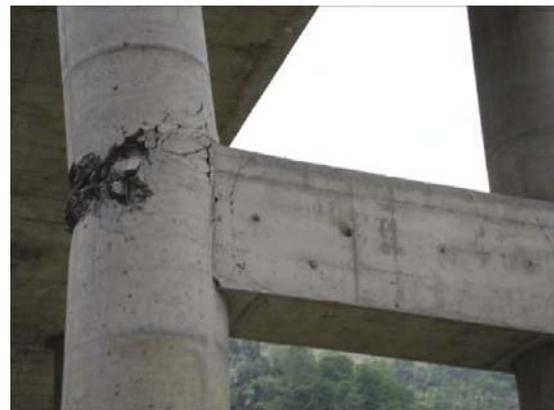
where the column and beam joints and the lateral braces were damaged as a result of strong shear force during the earthquake. The crack width was as large as 50 mm, also implying insufficient shear reinforcement. This failure indicated that the design of the column and beam junctures had at least two deficiencies: (1) insufficient shear capacity, especially in the column-beam juncture and (2) insufficient anchorage of rebar at the column end and improper design of the joint connecting the column and the lateral braces.

**Fig. 10 Juncture damage of Beihua Bridge (VII/XI)**

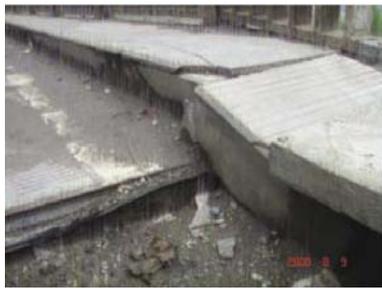
The rotation of the abutment and the excessive settlement of the foundation under the abutment are common modes of abutment damage. Figure 11(a) shows the settlement of the foundation under the abutment of the Shoujiang Bridge in Duwen Highway. The soil pressure in the longitudinal direction increased considerably as a result of the vertical ground acceleration, pushing the walls of the abutment to the water side. The impact on the abutment by the main girders generated larger passive soil pressure on the abutment, which pushed the lower part of the wall further towards the water side. Large settlement occurred when the lower part of the retaining wall was displaced towards the water, and consequently, cracks on the retaining wall developed because the top of the abutment was restrained by the superstructure. Figures 11(b) and 11(c) show inclined cracks in the abutment of the Duwen Highway and horizontal cracks in the abutment of the Gangou Bridge in Dujiangyan City, respectively. Damage observed to abutments of the bridges in this earthquake suggest that the abutment back wall, backfill, and approach slabs should be carefully designed and constructed to prevent collapse.

(a) Abutment collapse and broken deck on one-side of the Shoujiang Bridge (VII/IX)

Fig. 11 Abutment damage of RC bridge in Wenchuan earthquake

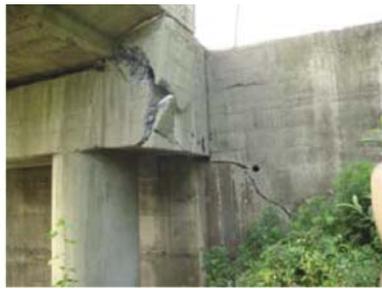
(b) Bridge in Duwen Highway (VII/IX)

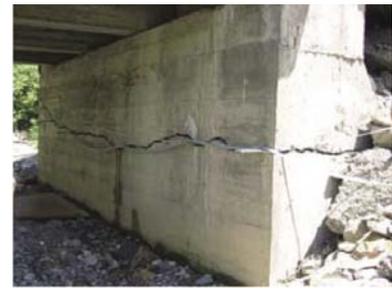
(c) Gangou Bridge (VII/IX)

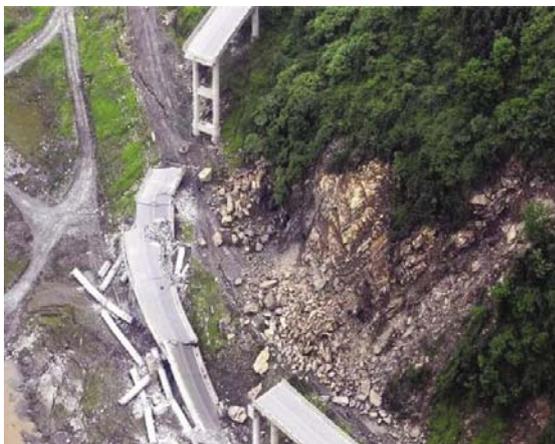
Town, the epicenter of the main central fault (Yingxiu-Beichuan Fault). The total length of the bridge is 495.55 m. The substructure was supported by twin-column piers connected by lateral braces, and the piers were about 20–30 m high. The common types of component failures observed for the Baihua Bridge include shear-flexural failure of the pier columns, expansion joint failure, shear key failure, juncture damage, lateral braces between

(a) Collapse of Baihua Bridge

Fig. 12 Collapse of curved segment of Baihua Bridge (VII/XI)

twin-column piers failure, rubber bearings failure. The possible causes of bridge collapse are summarized as follows: (1) the bridge is about 2 km from the epicenter of the main central fault, and a sub-fault passed through near the bridge so the fault effect was an important factor in the collapse of the bridge; (2) insufficient support length of the transversal beam and lack of longitudinal and vertical displacement restraints; (3) displacement of the piles due to the settlement of the newly deposited soil, amplified by the long pier columns; (4) excessive ground motion that displaced the curved girder from the bearing at the outer side of the curve, resulting in the collapse of the superstructure, initiating from the side towards the Yingxiu Town; (5) insufficient loops in the plastic hinge to provide necessary shear capacity; (6) improper design of the joint connecting the column and the transversal beam; and (7) complex dynamic behavior of the curved bridge in a complex mountainous region. Curved bridges with high pier columns usually exhibit complex dynamic behaviors when subjected to vertical and horizontal ground motions simultaneously. The eccentricity of the mass center may cause more problems by generating additional bending moments

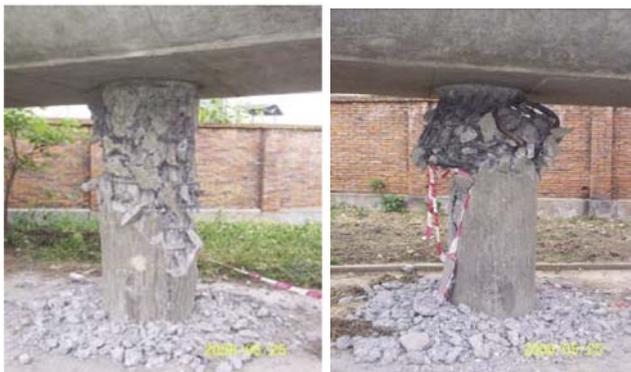
Some piers were fixed at their top to the box girder, i.e., the curved ramp, while others were connected to the superstructure via rubber bearings. The tops of the fixed piers were damaged during the earthquake since they experienced larger earthquake loads. The failures of 2# and 4# piers are shown in Fig.14, where the diameter of the pier columns was 800 mm, the circumference of the pier columns was reinforced with 20Φ25 rebar, and the ratio of longitudinal reinforcement was 1.95%. The hoop rebar distance of the pier column was about 100 mm to

(a) Failure of 2# pier of ramp bridge A

(b) Failure of 4# pier of ramp bridge A

Fig. 14 Pier damage to Huilan interchange ramp bridge (VII/IX)

200 mm with $\Phi 12$, and the corresponding volume ratio was about 0.26% to 0.56%. No region was found where the hoop rebars of the volume ratio were less than 0.3% and spacing was not more than 100 mm as specified by JTJ 004-89 (MCPRC, 1990). The JTG/T B02-01-2008 (MCPRC, 2008) requires the minimum volume ratio of transverse reinforcement in the potential plastic hinge region to be at least 0.4%. This may be one of the major causes of damage to the fixed piers at their top. The damage took a compression-shear mode, with steep diagonal cracks and an expanded core of concrete. Two lateral ties failed in tension while the longitudinal rebar did not yield. Under the cyclic action of the vertical earthquake load, the concrete of the piers was smashed, losing vertical loading capacity. Therefore, to prevent this type of failure, more lateral ties should be used in future designs.

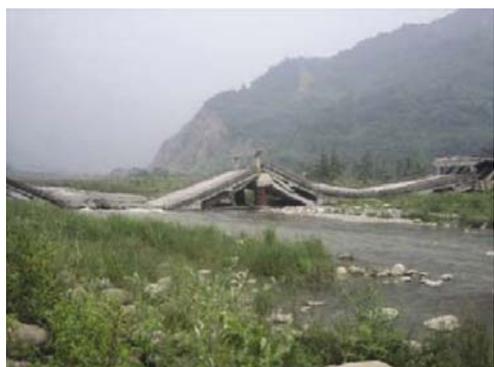
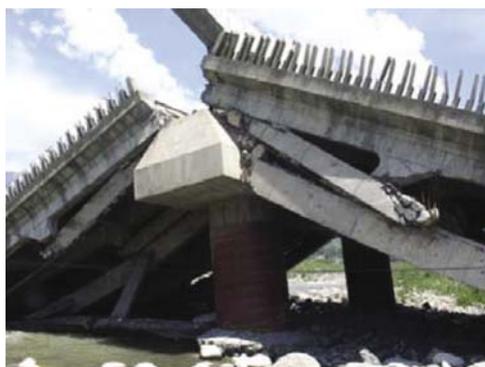
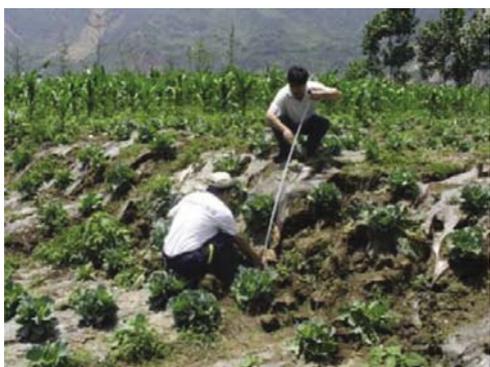
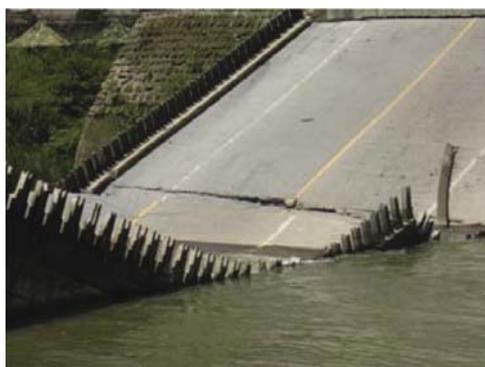
RC arch bridges have been widely adopted in the western mountainous area of China. The majority of these bridges survived the earthquake, with only a small percentage of failures. Figure 15 shows the collapsed Xiaoyudong Bridge, which was a RC frame arch bridge. The collapse of the bridge was due to the combined effect of the displacement of the fault near the bridge, liquefaction of the soil and insufficient reinforcement ($\Phi 6@200$) to resist the shear forces during the earthquake. The possible causes of its collapse are summarized as follows: (1) large topographical changes such as motion of the fault due to the strong earthquake; (2) large/uneven settlement of the foundation due to liquefaction of the soil; and (3) large internal forces or deformations that exceeded the capacity of the structural members.

(a) An overview

(b) Close up of the failed bridge and liquefaction about the piers

(c) Fault near the bridge, showing a ground surface sank 1.2 m

(d) Lateral-shift of the deck of about 30 cm

Fig. 15 Collapse of Xiaoyudong Bridge (VII/X)

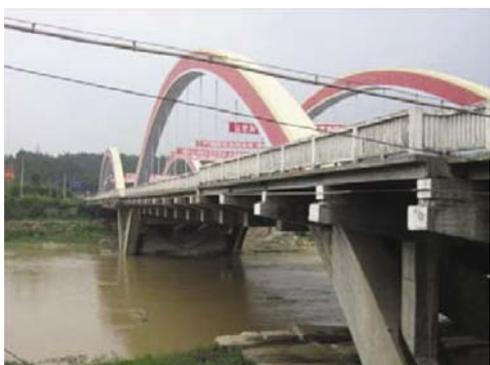
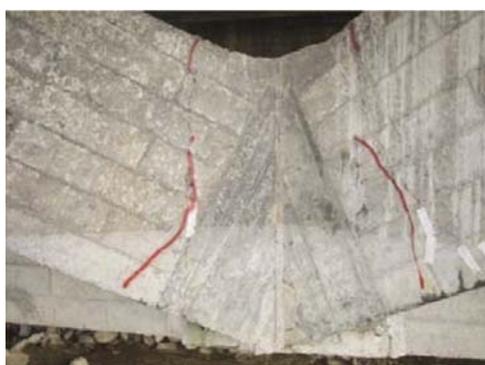
Figure 16 shows a two-span half-through RC arch bridge in Anxian County. The inclined struts were cracked with a maximum crack width of 8 mm as shown in Fig. 16 (b). Cracks also appeared in the main arch and had a maximum width of 5 mm.

(a) An overview

(b) Bottom struts crack

Fig. 16 Damage to the Anzhou RC arch bridge (VII/IX)

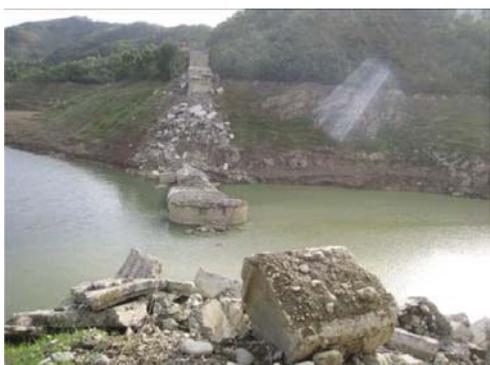
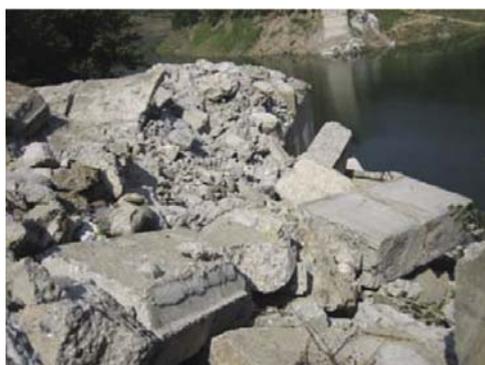
Figure 17 shows the collapsed Jingtianba Bridge in Qingchuan County. This bridge was built in 1999, and very lightly reinforced. The major reason for the collapse of the bridge was its poor design and construction quality. Other similar bridges in the near region did not suffer damage during the earthquake.

(a) An overview of the collapsed bridge

(b) Reinforcement was lacking

Fig. 17 Collapse of Jintianba Bridge (VII/VIII)

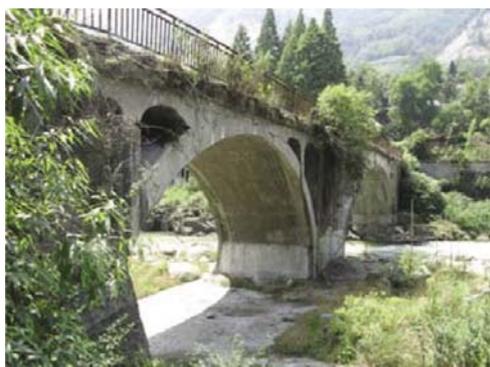
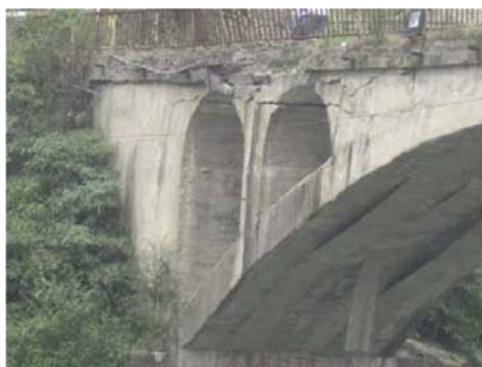
Figure 18 shows the Miaoba Bridge in Dujiangyan City. The rib of the main arch and the vertical strut were severely damaged. Note that this bridge had been retrofitted before the earthquake using FRP to strengthen the main arch. It seemed that the retrofitting did not help enhance the seismic resistance of the bridge.

(a) Overview of the Miaoba Bridge

(b) Detail of Miaoba Bridge damage

Fig. 18 Miaoba Bridge (VII/XI)

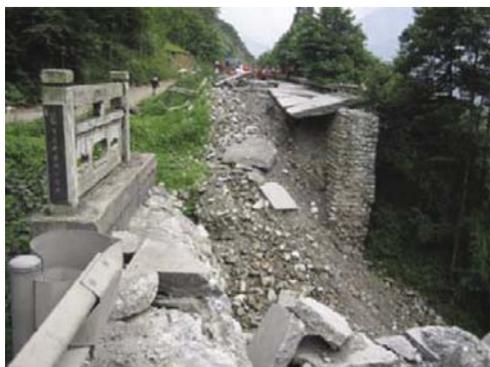
Masonry arch bridges are very common in the county road system in the western mountainous area of China. The majority of these structures survived the earthquake, and resumed carrying traffic loads soon after the event. Only a few masonry arch bridges failed during the earthquake. Figure 19 (a) shows the collapse of Yingxin

(a) Collapsed Yingxin arch stone bridge (VII/IX)

Fig.19 Damage to masonry arch bridges

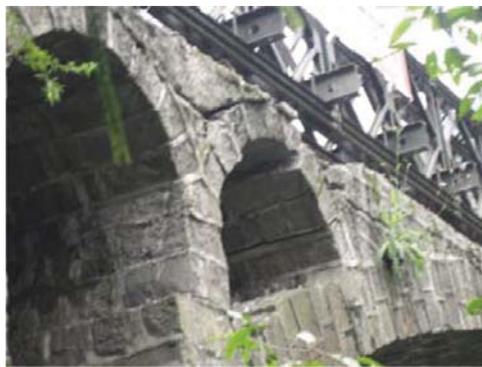
Bridge in Shifang City. The ventro-arch of the Guantong Bridge in Shifang City was severely damaged as shown in Fig. 19 (b); furthermore, major cracking of its main arch shoulder and footing occurred. The major reason masonry arch bridges survived the earthquake is that they have relatively short spans, were well constructed, and in particular, were founded on a rigid base.

(b) Ventro-arch damage (VII/IX)
