# Lessons learned from the “5.12” Wenchuan Earthquake: evaluation of earthquake performance objectives and the importance of seismic conceptual design principles

Wang Yayong<sup>†</sup>

*Institute of Earthquake Engineering, China Academy of Building Research, Beijing 100013, China*

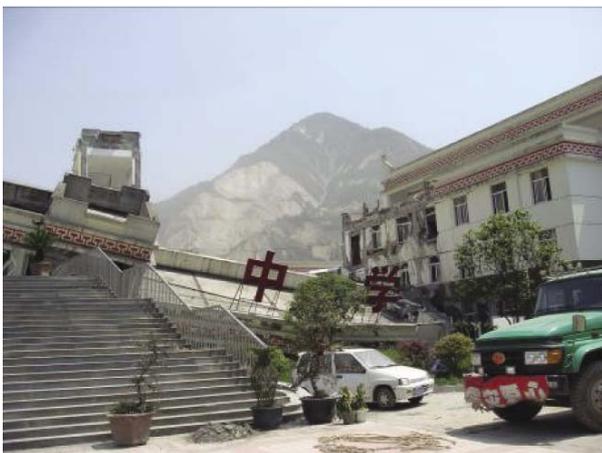
Fig. 1 Collapsed school building (left) in Yingxiu Town (VII/XI) (Note: VII/XI means the specified intensity /estimated intensity and same below)

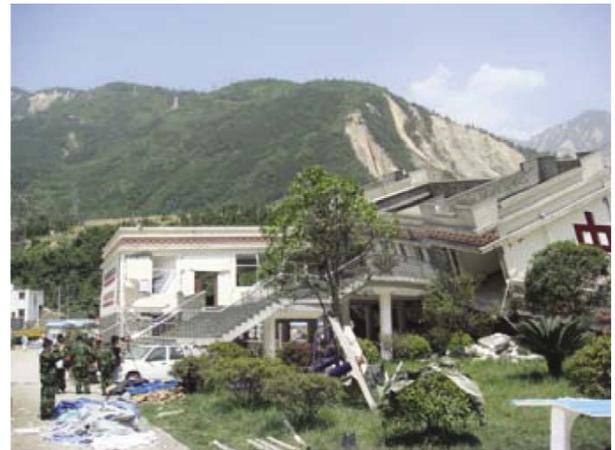
Fig. 2 Collapsed school building (right) in Yingxiu Town (VII/XI)

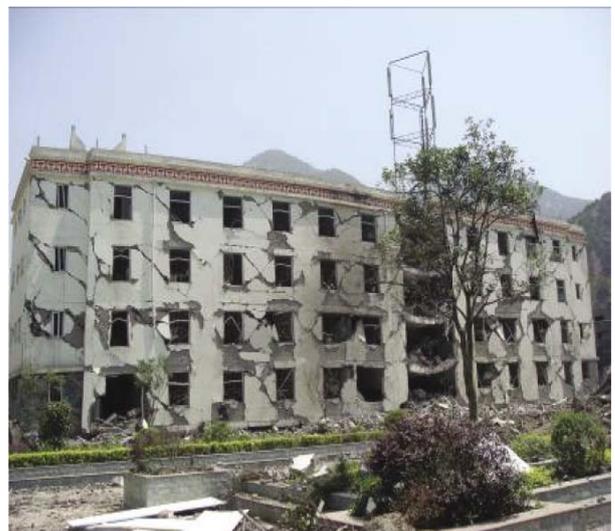
severe damage with many cracks within the walls, but did not collapse due to the presence of a combination of RC tie-columns and tie-beams (see Fig. 3).

Fig. 3 Damaged official building in Yingxiu Town (VII/XI)

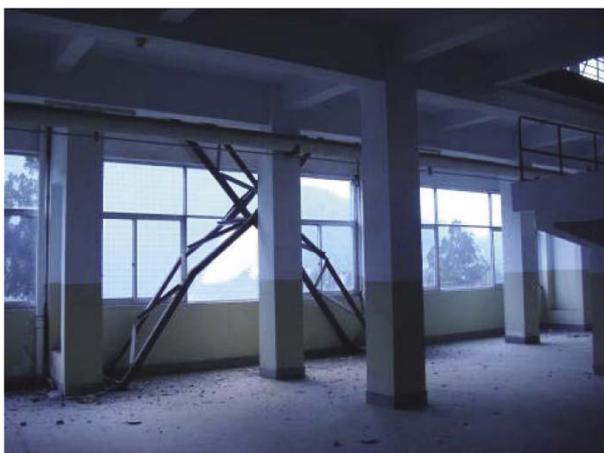
Bracing systems are widely used in industrial buildings. The buckling of braces may absorb and dissipate earthquake energy to prevent the frame columns from collapse. Figure 4 shows a failure mode of the brace in an industrial buildings in An Xian County, located in a region with an estimated intensity of VIII according to the Chinese code. Figure 5 shows two 4-story buildings in Pingwu County, one RC frame structure and the other a masonry structure, that were under construction when the earthquake occurred. The span of the RC frame structure (on the left) was severely damaged, but the masonry structure (on the right) had less damage because the brick walls were confined by tie-columns and tie-beams, leading to a significant increase in the integral rigidity of the building under

Fig. 4 Buckling brace between columns of an industrial building in Yingxiu Town (VII/XI) of Anxian County (VII/VIII)

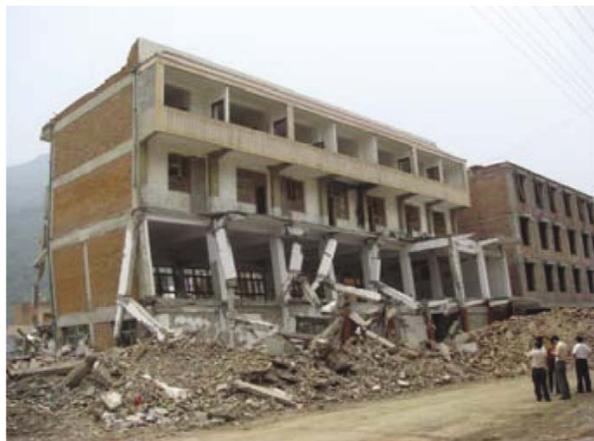
Fig. 5 Two buildings side by side in Pingwu County (VII/IX)

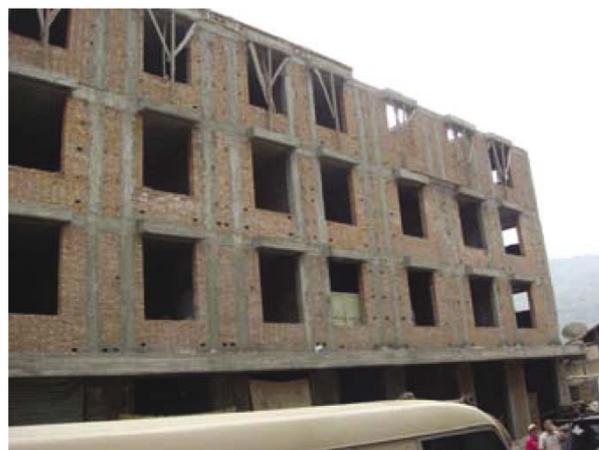
large deformation (see Fig. 6). The estimated intensity at this location was IX.

Fig. 6 Confined masonry building at the rear of that in Fig. 5

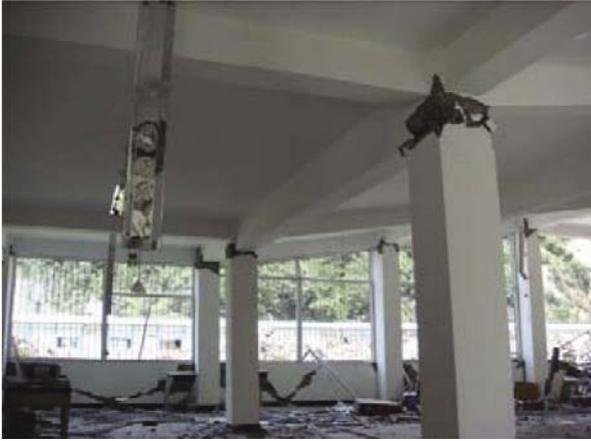
**Fig. 7 Plastic hinges at column tops of a dining hall at the ground floor of the Xuankou Middle School in Yingxiu Town (VII/XI)**

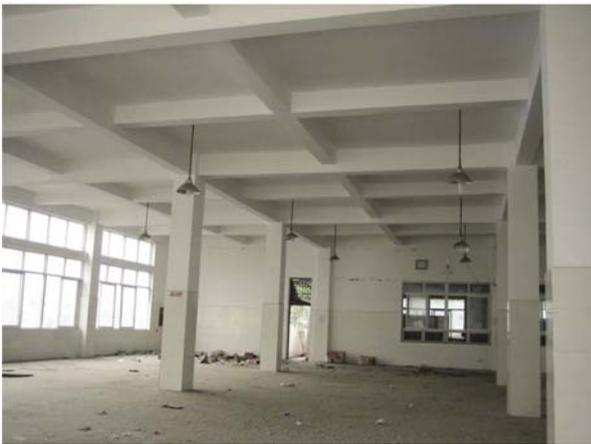
**Fig. 8 The dining hall at the second floor of the building shown in Fig. 7 remains intact**

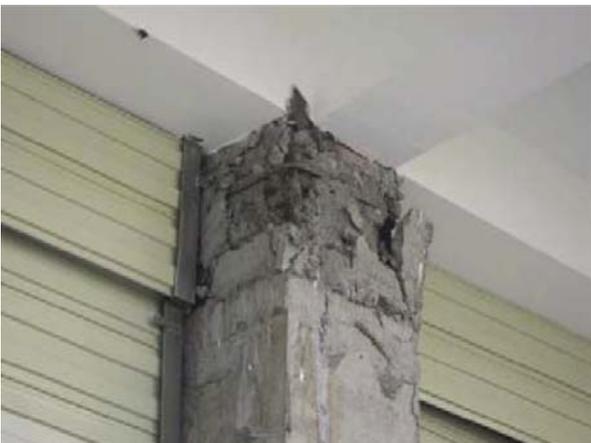
**Fig. 9 Plastic hinge at the top of a column (VII/XI)**

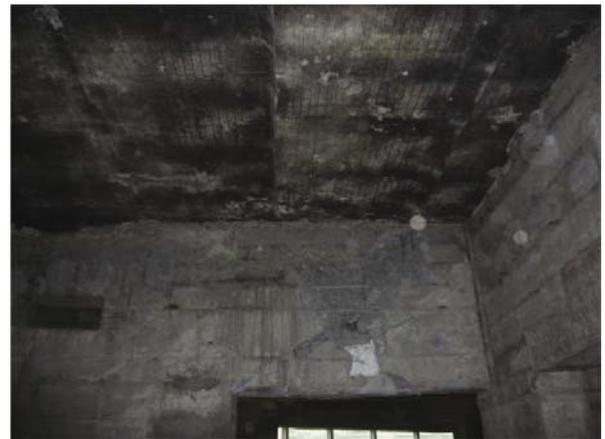
**Fig. 10 Damaged high coupling beam of a shear wall structure in Pengzhou City (VII/VII)**

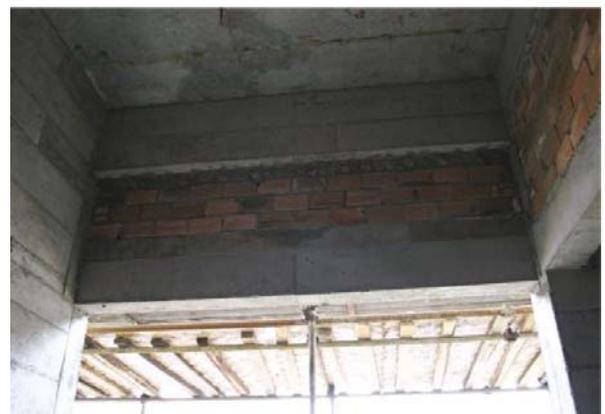
when the level of seismic action is beyond the minor earthquake level. This prevents damage to the adjacent shear walls because the earthquake energy has been dissipated and absorbed by the slightly damaged coupling beams. Code GB50011-2001 regulates that “Besides the normally required reinforcement hoop, details of cross steel should be provided for the coupling beam with a span-to-depth ratio less than 2 and the thickness of the wall less than 200mm.” The reason for this is to improve the shear resistance of the coupling beam and satisfy the requirement of the “strong shear-weak moment.” Such ductile detailing of the reinforcement has been illustrated in laboratory tests, but the observed damage did not show the desirable results. The coupling beam in a shear wall building in Pengzhou City was seriously damaged in a typical shear failure mode as shown in Fig. 10. However, the twin coupling beams of two frame-shear wall structures in Chengdu City and Xi’an City performed very well. The brick masonry was broken to prevent the coupling beam and the wall itself from failure (see Figs. 11 and 12).

**Fig. 11 Twin coupling beam of a frame-shear wall structure in Chengdu City (VII/(VI-VII))**

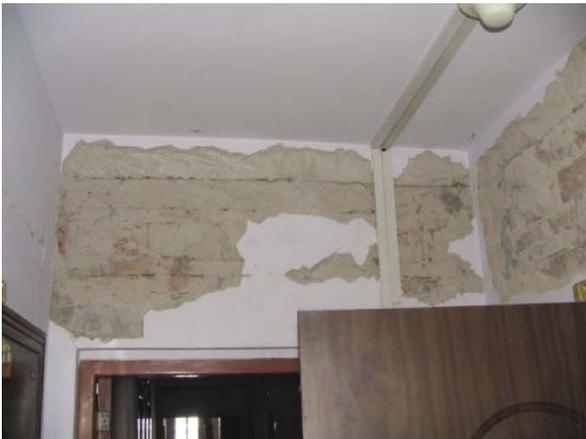
Fig. 12 Twin coupling beam of a frame-shear wall structure in Xi'an City (VII/(VI-VII))

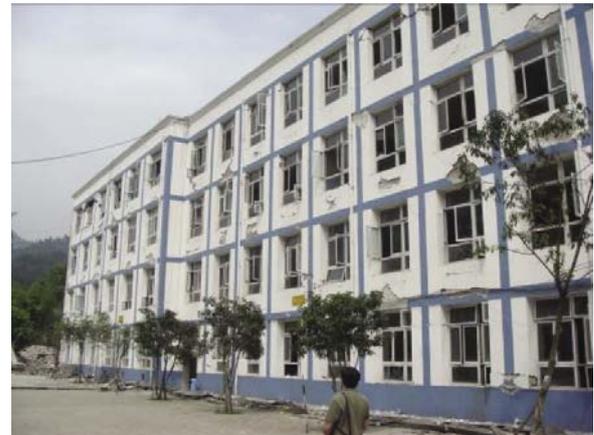
The precast RC multi-hole floor slab has been commonly used for schools and residential buildings in China. The integrity of the connections between precast RC structural members is very important to ensure the proper integration of the structure as required by Clause 3.5.5 of Chinese Code (GB50011-2001). Masonry structures are often constructed of brittle materials. Confined masonry structures have been designed and extensively studied after the 1976 Great Tangshan Earthquake in China. The combination of RC tie-column and tie-beam forms a restraining frame for masonry walls that significantly enhances the ductility and integration of the structure under large deformations. This specific type of confined structure has been widely used in earthquake-prone regions throughout China. It is seen from past earthquakes that the three earthquake performance objectives can be achieved for buildings that were designed and constructed by strictly following the detailing for tie-column and tie-beam as required in the current seismic code. Figure 13 shows a confined

masonry school building that sustained many inclined cracks on the brick walls that were restrained by tie-columns and tie-beams, and survived collapse when subjected to a very high earthquake intensity level.

Fig. 13 Damaged masonry school building in Bailu (VII/VIII)

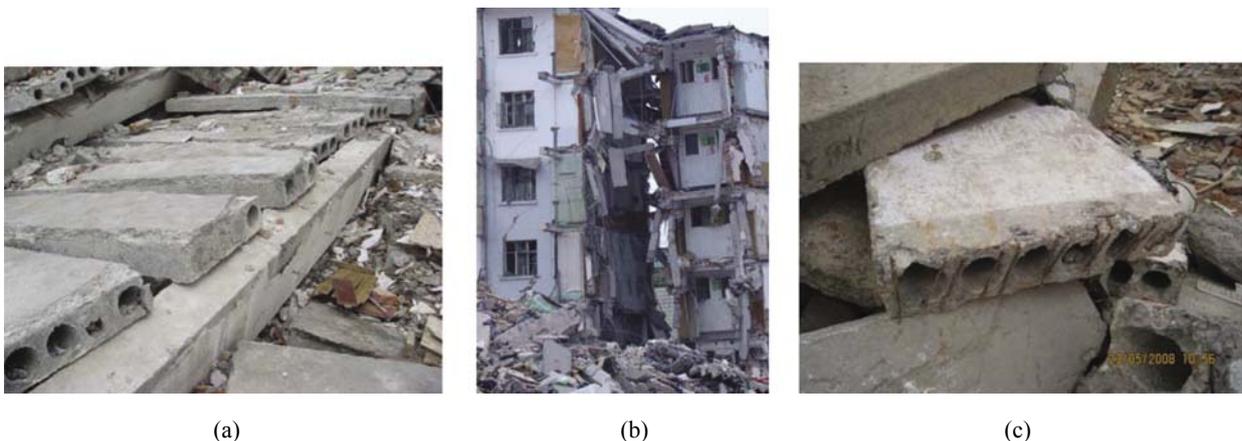
Unfortunately, some of masonry structures collapsed partly or entirely in the Wenchuan Earthquake due to the poor connection between the precast RC floor slabs and tie-beams, or due to breaking or overturning of the brick walls from the lack of restraints to the tie-columns and tie-beams. Figure 14 shows that there are no connection details for the floor slabs that fell.

Fig. 14 Poor connections between precast RC floor slabs and tie-beam

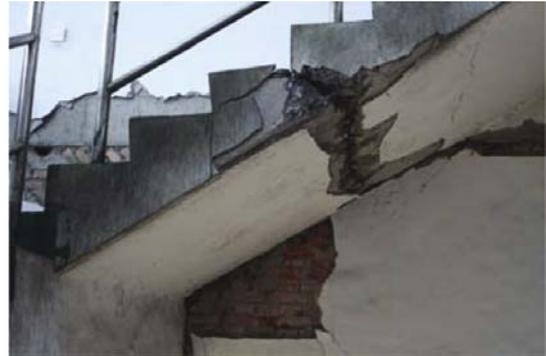
provided at the corners of stair shafts, lift tubes, and at the joints of transverse and longitudinal walls on the step level. Clause 7.3.8 requires that a valid connection be detailed between beams for steps and platforms; and the tie-column must be extended up to the top and be connected to the tie-beams of the stair shaft that protrude beyond the roof. Figure 12 shows a collapsed stair shaft of a 3-story school building caused by the breaking of the wall. Figure 15 shows a collapsed stair case of a three-story school building. Fig. 16 shows the failure of steps caused by the structural partition moving to the lower 1/3 length of the stair segment. The damaged step beam and the stair segments that fell are seen in Figs. 17 and 18, respectively.

**Fig. 17** Fractured stair beam at its lower 1/3 position (VII/(VIII-IX))

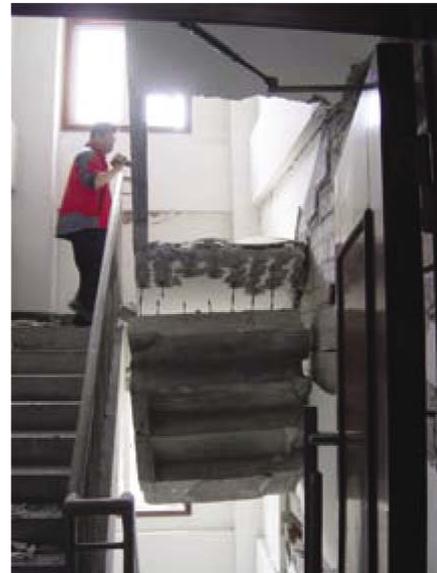
**Fig. 18** Falling stair segment

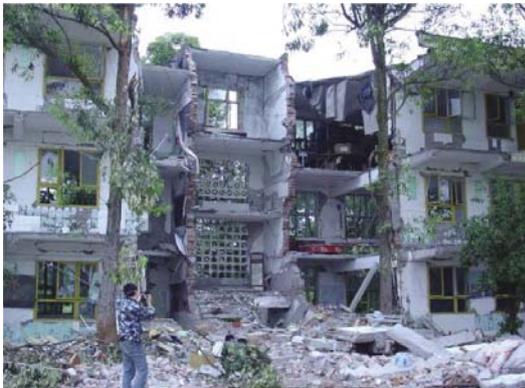
**Fig. 15** Collapsed stair shaft of a three-story school building in Mianzhu County (VII/(VIII-IX))

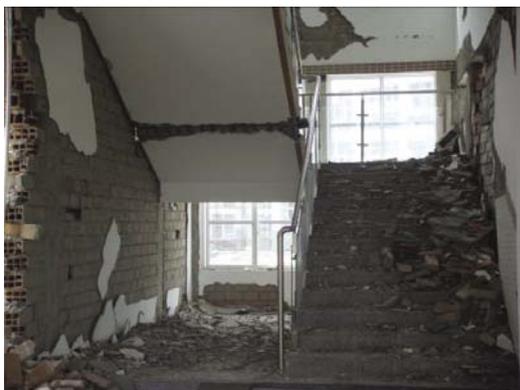
**Fig. 16** Damaged stair shaft of school building in Dujiangyan (VII/(VIII-IX))

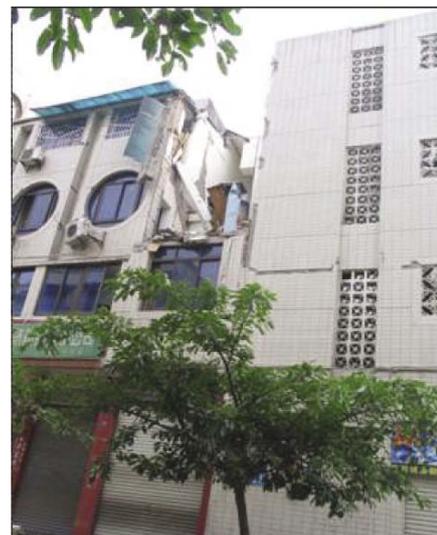
Code GB50011-2001 requires that a seismic partition be provided for buildings to have adequate spacing depending on the specified intensity, type of structure, structural materials, and building height. The upper buildings should be completely separated along the partition to avoid knocking. Figure 19 shows a masonry structure that partly collapsed due to the knocking of

**Fig. 19** Partial collapse of building due to knocking along the partition (VII/VIII)

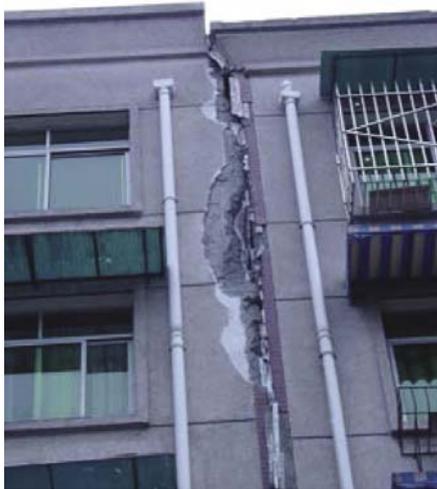
buildings along the partition. Figure 20 shows knocking of two multi-story masonry buildings. It is not always necessary to have a partition if the building has a regular configuration in plan or elevation.

Fig. 20 Knocking of partition (VII/VIII)

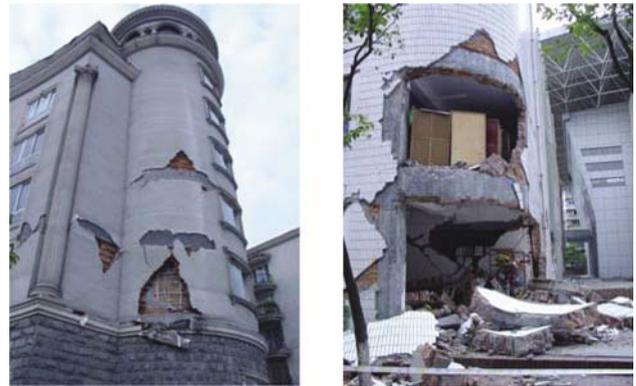
The earthquake actions in two horizontal directions may cause rotation of buildings as seen in Fig. 21, where the corner walls on the top of the masonry building rotated slightly. This means that the building sustained two-horizontal seismic actions at the corner. When the earthquake forces are transferred along the *X* and *Y* axes in the building plan, the walls at the corner should remain connected tightly. If an opening exists near the corner, structural failures will certainly occur (see Fig. 22).

Fig. 22 Failure of walls at the corner of two buildings (VII/VIII)

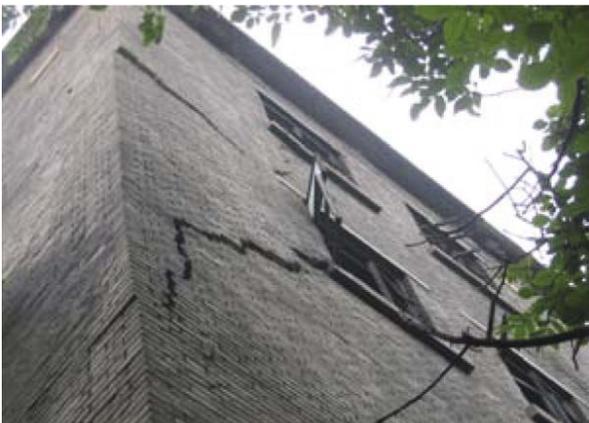
Fig. 21 Rotation at upper corner of a masonry building (VII/VIII)

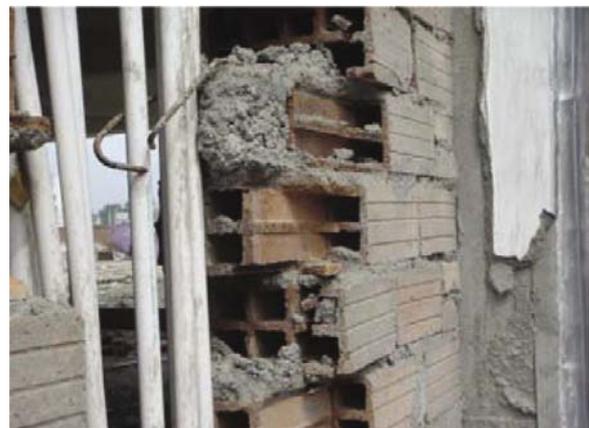
Fig. 23 Damaged infilled wall of perforated brick of a school building in Dujiangyan (VII/(VIII-IX))

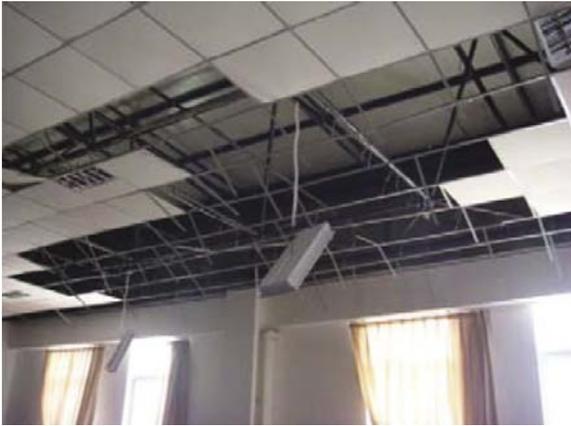
**Fig. 24** Damaged ceiling of a school building in Deyang City (VI/VII)

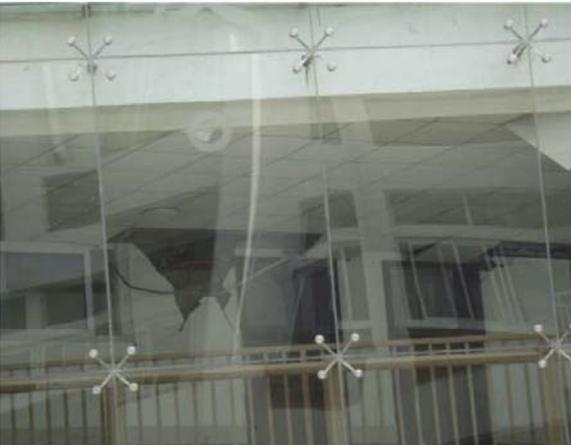
**Fig. 25** Glass cladding of a school building remains intact in Dujiangyan (VII/(VIII-IX))

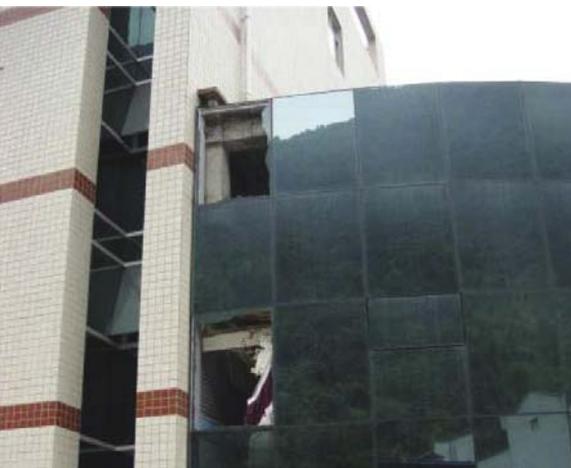
**Fig. 26** Two slices of glass fell down from the cladding in Anxian County (VII/IX)
