A preliminary report on the Great Wenchuan Earthquake

Abstract: The May 12, 2008 Great Wenchuan Earthquake has resulted in more than 68,858 deaths and losses in the hundreds of billions RMB as of May 30, 2008, and these numbers will undoubtedly increase as more information becomes available on the extent of the event. Immediately after the earthquake, the China Earthquake Administration (CEA) responded quickly by sending teams of experts to the affected region, eventually including over 60 staff members from the Institute of Engineering Mechanics (IEM). This paper reports preliminary information that has been gathered in the first 18 days after the event, covering seismicity, search and rescue efforts, observed ground motions, and damage and loss estimates. The extensive field investigation has revealed a number of valuable findings that could be useful in improving research in earthquake engineering in the future. Once again, this earthquake has shown that the vertical component of ground motion is as significant as horizontal ground motions in the near-source area. Finally, note that as more information is gathered, the numbers reported in this paper will need to be adjusted acc

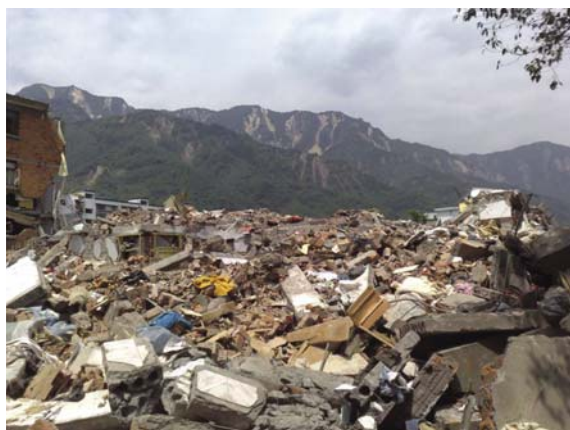
There are many observations from the field. The first is the vulnerability of schools and hospitals. In almost all the cities and towns where there was heavy damage, schools and hospitals were among the worst. The main shock occurred during the day on Monday, and the deaths and injuries basically occurred in crowded public places or regions, i.e., schools, hospitals and office buildings. This tragic fact calls for serious reconsideration of seismic design and construction for buildings of important facilities such as schools and hospitals. Figure 5 shows the complete destruction of four buildings of the Dongqi Middle School in Hanwang town of Mianzhu city, which resulted in hundreds of students losing their lives. It can be seen from the picture that the buildings were totally devastated and did not seem to be designed and/or built according to current seismic design standards.

Fig. 5 Complete destruction of four buildings of the Dongqi Middle School in Hanwang Town, Mianzhu City

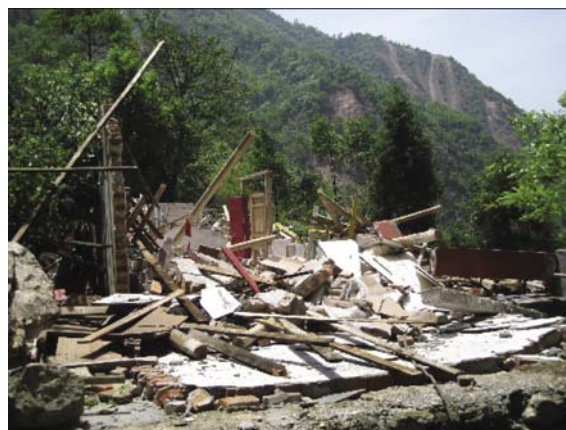
Yinghua in Shifang City. Almost all the buildings in the town were destroyed, which demonstrates the typical heavy damage to buildings in rural areas. Figure 7 exhibits a similar damage pattern in a small town and remote village in Shifang City where every building in the picture is completely destroyed.

Fig. 7 Collapsed building in a village located halfway up the mountain in Shifang City

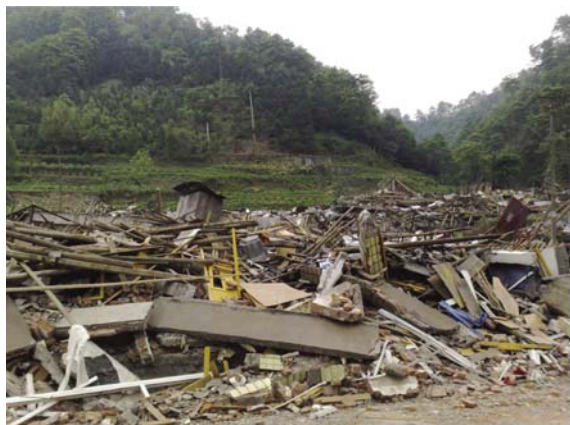
The second is the vulnerability of buildings in rural areas. The current design code does not cover buildings in rural areas, making these areas vulnerable when an earthquake occurs. The structures in the countryside without any measures to counter earthquake excitation suffered the worst damage, causing a huge number of casualties as well as an enormous economic loss. Figure 6 shows the complete destruction of a small town called

Fig. 6 Complete destruction of Yinghua Town, Shifang City

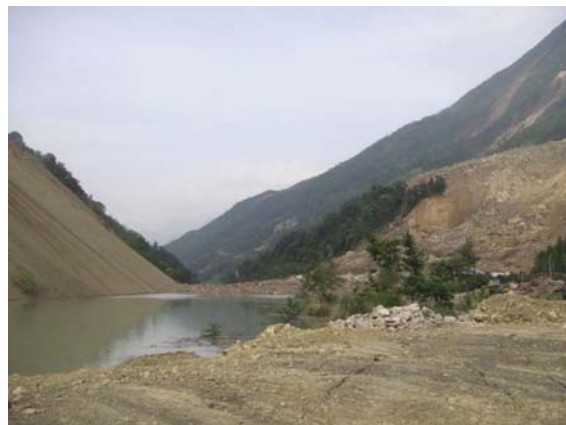
The second is the quake lakes, formed by landslide-induced reservoirs. It is reported that there are 34 landslide-induced reservoirs in the area with the largest one being the Tangjia Mountain quake lake. This lake has a dam height between 82 and 124 m, a total earth-rock volume of 20 million cubic meters and a water volume over 171 million cubic meters as of May 30, 2008. The Tangjia Mountain quake lake (see Fig.8) is a threat to the lower reaches, where counties and cities like Beichuan, Anxian, Shifang, Mianzhou, Pengzhou, and Deyang etc. and some large pre-existing reservoirs and hydraulic power stations are located. For safety purpose a lot of active and positive measures have been taken (<http://focus.cnhubei.com/original/200805/t325909.shtml>) to reduce the potential risk from the Tangjia Mountain quake lake. For safety purposes, many active and positive measures have been taken (<http://focus.cnhubei.com/original/200805/t325909.shtml>) to reduce the potential risk from these quake lakes.

Fig. 8 Partial view of Tangjia Mountain quake lake

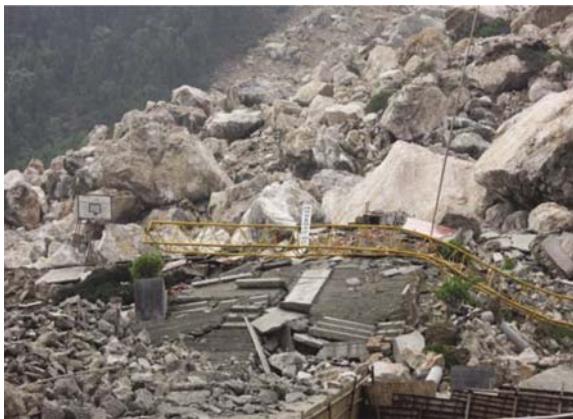
system by the landslides and rock slides. This type of damage not only blocks transportation to the affected area, but also causes direct loss to roads, vehicles and people on the scene. Figure 9 shows rock slides in Beichuan County that completely destroyed the new site of the Beichuan Middle School. Figure 10 shows the trucks smashed and trapped by rolling boulders in Gaochuan of Anxian County. Such phenomena, smashed cars and trucks and casualties, were observed everywhere along the highways. Figure 11 shows the Beichuan county town damaged by a combination of landslide and ground shaking. Figure 12 shows a two story building in Beichuan county town. The top floor was destroyed and thrown to the middle of the street at a distance of more than 15 m apart.

Fig. 9 Rock slides in Beichuan County

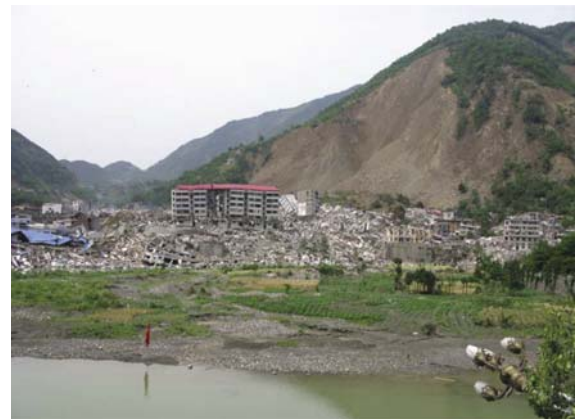
Fig. 11 Beichuan county town damaged by the combination of landslide and ground shaking

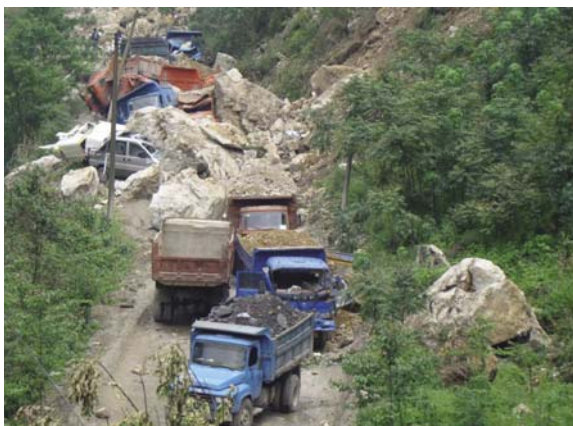
Fig. 10 Trucks smashed and trapped by rock slides

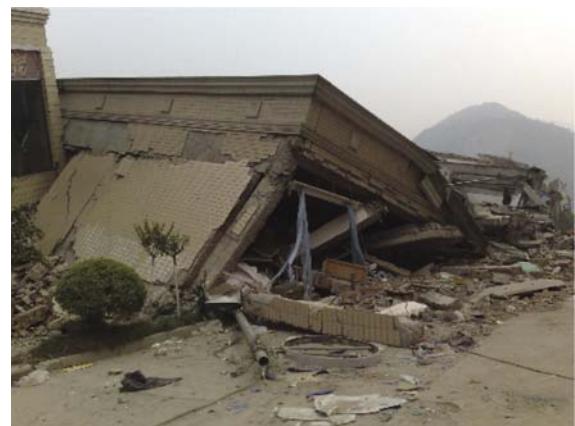
Fig. 12 The upper part of a two-story building destroyed and thrown for a distance of more than 15m

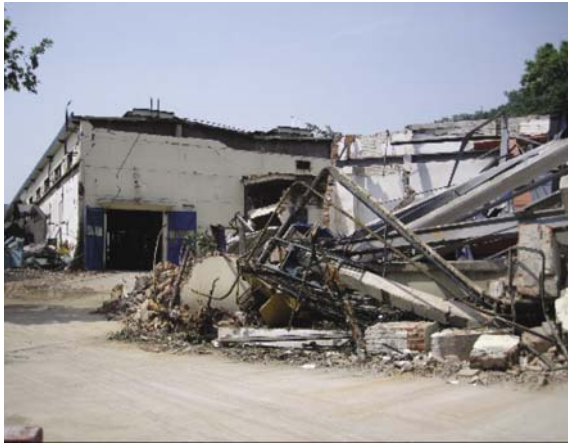
Many damaged industrial factories in the affected area were built in the 1960s and 1970s. At that time, less attention was paid in general to the seismic design of buildings and facilities. The Dongfang Steam Turbine Works located in Hanwang town, Mianzhu City with more than 20,000 staff and workers suffered

heavy damage. Figure 13 shows some of the damaged buildings of the Dongfang Steam Turbine Works. Note that the building at the rear of the picture did not show any damage from the earthquake because of its strong connections between the beams and columns, further stressing the importance of and need for proper seismic design and construction.

Fig.13 Part of the damaged buildings of the Dongfang Steam Turbine Works at Hanwang Town, Mianzhu City

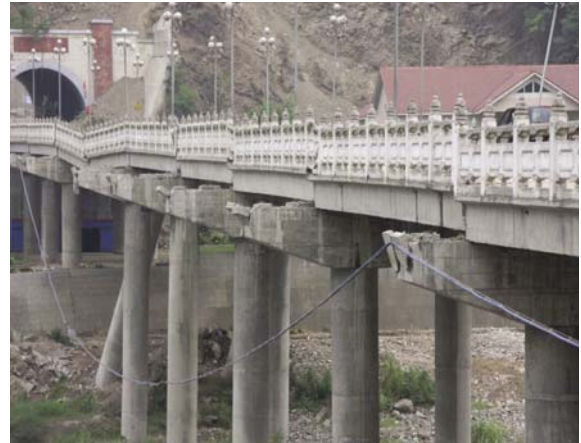
More than 400 bridges were damaged in the affected area, including simply supported beam, steel truss, arch and suspension bridges, etc. Damage seems to be due to a combination of ground surface rupture and strong ground shaking. Some typical bridge damage is shown in Figs. 14 through 18.

Fig. 16 Damage to a bridge, including a falling deck at the center, at a town in Beichuan County

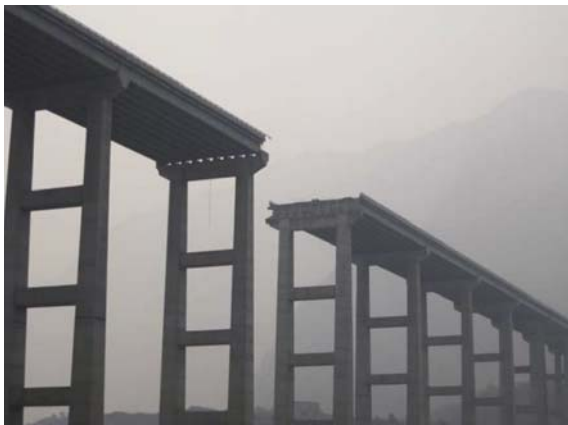
Fig. 14 Damage to the Yingxiu Bridge caused by the falling of one of the central spans. The bridge is located at the upstream of the Minjiang River at Zipingpu Reservoir

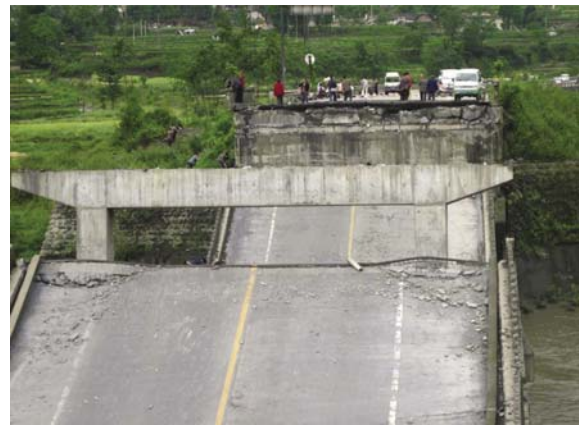
Fig. 17 Xiaoyudong Bridge, two spans near one of the abutments fell down

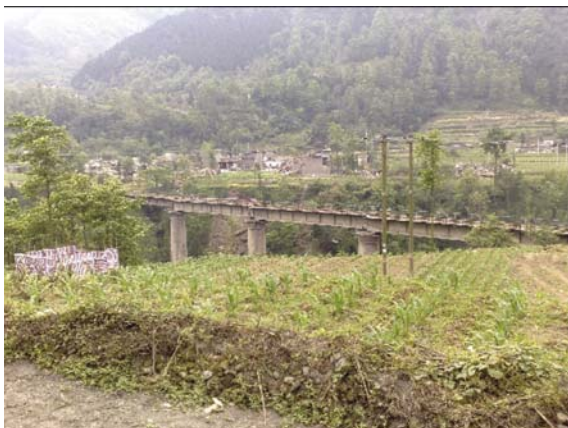
Fig. 15 A severely damaged railway bridge near Yinghua Town, Shifang City

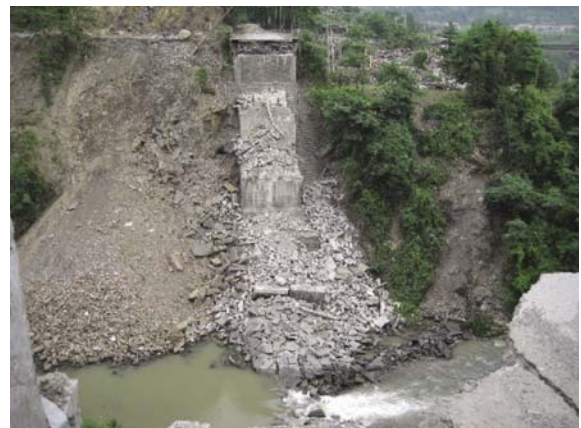
Fig. 18 A totally collapsed bridge, the only access from Hongbai Town to the mountain area from the Shifang City

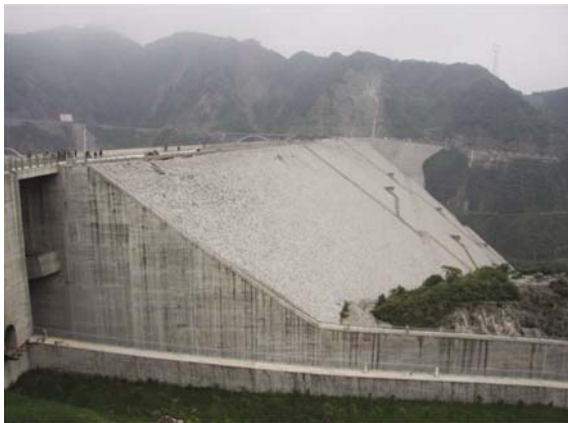
In the affected area, in addition to bridges, many other types of lifeline engineering structures and facilities suffered damage to different extents. Zipingpu reservoir, one of the largest reservoirs along the Minjiang River, has a rock-fill dam with a concrete cover plate. The dam has a height of 156 m and a length of 663 m. The maximum installed capacity of this hydropower station is 1.112×10^9 m³. The dam was designed for a seismic intensity of 8. It was said that a settlement of

73.9 cm and a horizontal displacement of 10 mm along the river direction were observed according to the chief engineer of construction during our survey. A partial view of the dam is shown in Fig.19. Figure 20 shows an overturned train.

Fig. 19 Zipingpu Reservoir had slight damage to its dam both on the top and the concrete cover plate of the downstream side

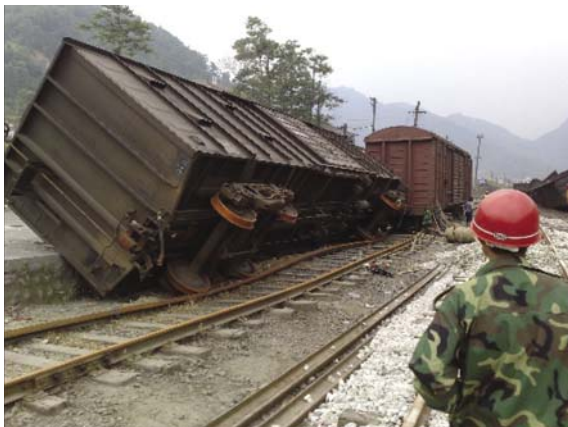
Fig. 20 The train overturned and the railway track slightly deformed at the Yinghua Town, Shifang City

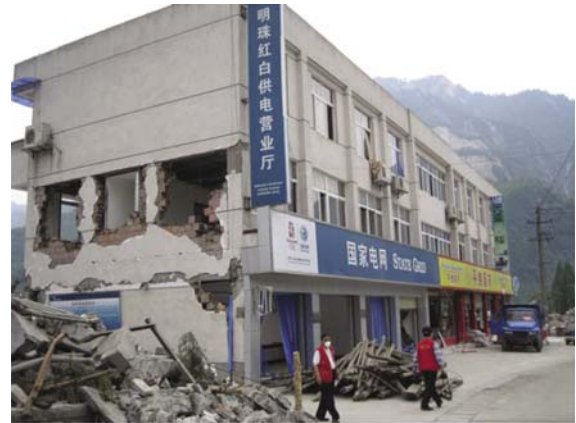
Thus far, earthquake damage to different structures and facilities had been described. Even in towns with almost complete destruction, there are always a few building that did not suffer heavy damage. We believe it is valuable to provide some information on the importance of proper seismic design and high-quality construction gained during our survey. It is important to point out that even in cities and towns like Beichuan and Hanwang, where almost every building suffered damage, those that were properly designed and built performed very well during the earthquake and did not completely collapse. Some buildings resisted severe damage and thus exceeded expectations. Figure 21 shows the solo standing building in a small town called Hongbai in

Shifang City. Note that almost all the buildings nearby were completely destroyed except this one. During the field investigation, large surface cracks and huge ground displacement was observed near this building. Initial survey by geologic experts proved that there was a fault rupture crossing this town, making it one of the worst hit areas during the earthquake. Detailed investigation of the structure proved that the building was properly designed and built and incorporated recommended seismic design procedures. Figure 22 shows the standing building of the Beichuan Tea Factory in Beichuan county town, another town heavily damaged during this earthquake. Close investigation proved that there was very minor damage to the walls and the structure could be used after only slight repairs. Figure 23 provides a comparison of a building with minor damage and one that was destroyed nearby in the severely affected Beichuan county town. Some low-rise buildings in the mountain area of the severely affected region of Shifang City were found to be only slightly damaged as shown in Figs. 24 and 25.

Fig. 21 The only standing building in Hongbai Town, Shifang City

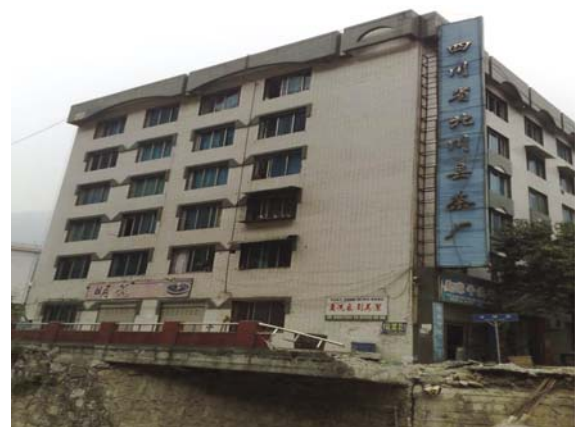
Fig. 22 The office building of Beichuan Tea Factory in Beichuan county town

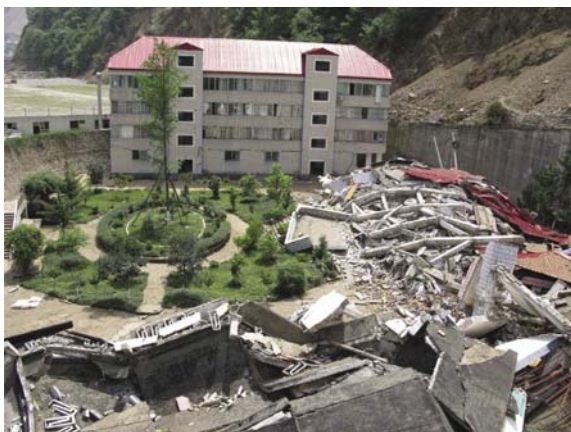
Fig. 23 Comparison of a building with minor damage and one nearby that was destroyed in the severely affected Beichuan county town

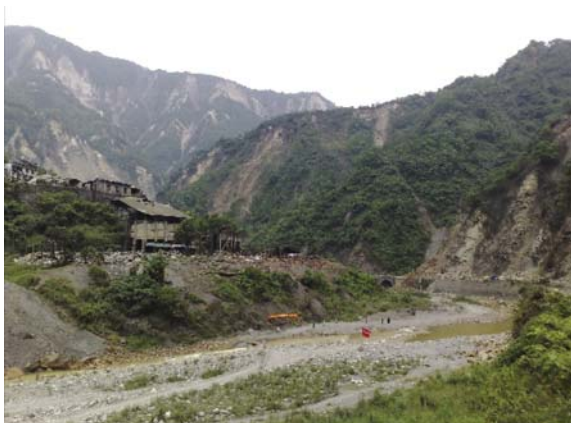
Fig. 24 Some buildings located halfway up the mountain in Shifang City seem to have only minor damage while at the opposite side heavy landslide occurred

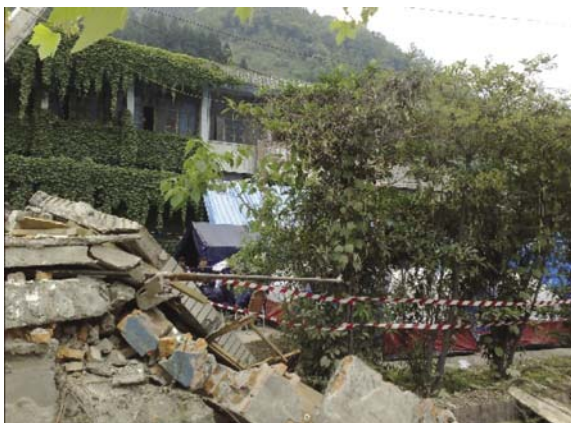
Fig. 25 A one-story building located in mountain region in Shifang City has no obvious damage
