Impact of intensity and loss assessment following the great Wenchuan Earthquake

Abstract: The great Wenchuan Earthquake occurred on May 12, 2008 in the Sichuan Province of China, and had a magnitude of 8.0. It is the most serious earthquake disaster in China since the great Tangshan Earthquake ($M_s=7.8$, July 28, 1976). According to official reports, there were 69,225 deaths, 379,640 injuries and 17,939 missing as of Aug. 11, 2008. The China Earthquake Administration quickly sent hundreds of experts to the field immediately after the event, to investigate the damage and assess the economic losses. This paper emphasizes the impact of seismic intensity and presents a preliminary loss assessment. A brief description of the geological features of the affected region is provided, followed by a summary of the earthquake damage. An isoseismal map is developed that shows that the high intensity region is distributed like a belt around the seismogenic fault, and that the epicentral intensity reached XI (Chinese Intensity Scale, similar to the Modified Mercalli Scale). The direct economic loss resulting from the earthquake is 692 billions RMB (about 100 billions US\$).

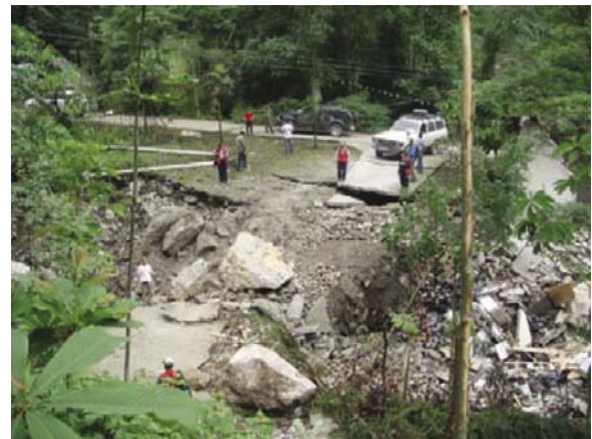
Fig. 3 A big vertical dislocation of 4.7m in Hongkou Town, showing strong thrust movement of the Longmenshan fault

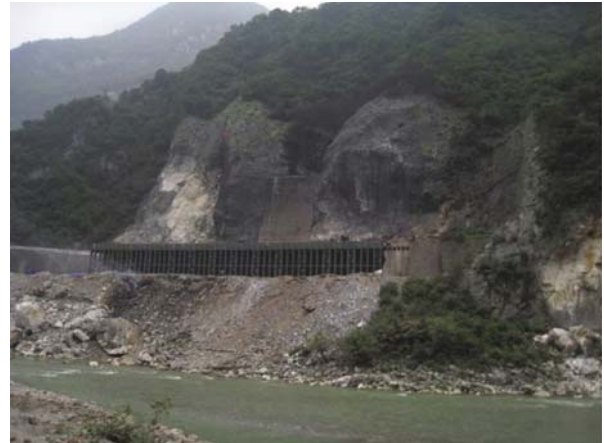
Figure 7 shows a huge landslide that buried an entire village, causing many casualties, and Figure 8 shows a landslide that damaged a railway, sealed a tunnel and caused a fire on an oil train.

Fig. 8 Landslide damaged railway, sealed tunnel and caused fire of oil train

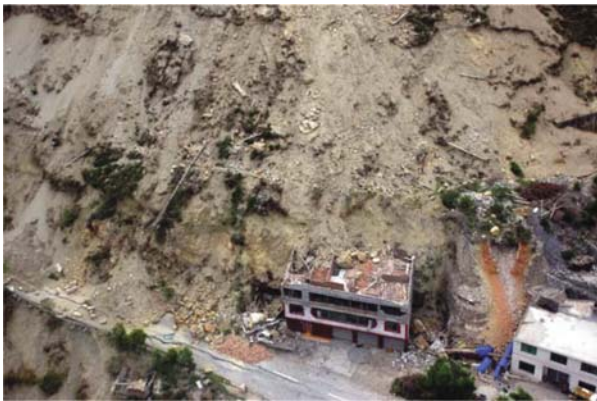
Figure 6 shows a large landslide that blocked a road and a destroyed building in the disaster area.

Fig. 6 Landslide buried road and building in Wenchuan County

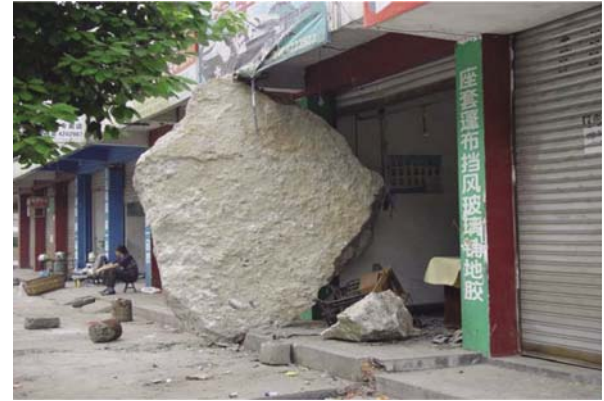
- (3) Rockfalls occurred in many places, even in areas far from the epicenter, resulting in damage to building, houses and cars, in addition to many casualties (Fig.9).

Fig. 9 A big rolling rock killed 2 people and stopped at the front of a shop in Anxian Town

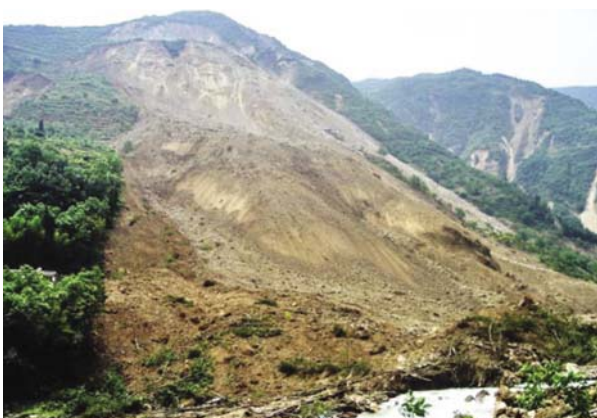
Fig. 7 Landslide buried village and killed people in Beichuan County

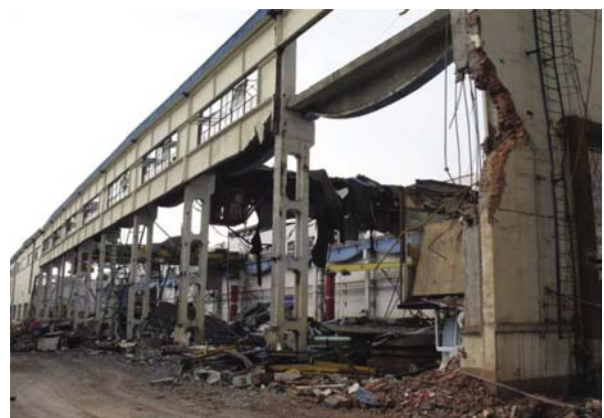
Fig. 10 Damaged factory building of Dongfang Steam Turbine Works in Hanwang Town

Guangyuan, and Dujiangyan cities, where many well-known businesses in China are located. Many large factories suffered severe damage (Fig.10) and had to

relocate. Significant losses, including direct and indirect loss, resulted from damage to industrial buildings and equipments.

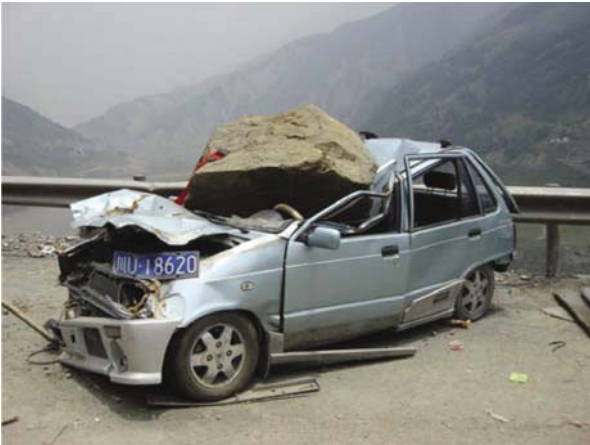
that caused serious casualties, such as landslides that buried villages, and falling rocks that hit houses, cars and trucks (see Fig. 14). Some of these disasters occurred far from the epicenter, where rockfalls were the main cause of casualties.

Fig. 14 Rolling rocks hit houses, cars, and buses, killed people
