Seismic damage of highway bridges during the 2008 Wenchuan earthquake

Abstract: Many highway bridges were severely damaged or completely collapsed during the 2008 Wenchuan earthquake. A field investigation was carried out in the strongly affected areas and over 320 bridges were examined. Damage to some representative highway bridges is briefly described and a preliminary analysis of the probable causes of the damage is presented in this paper. The most common damage included shear-flexural failure of the pier columns, expansion joint failure, shear key failure, and girder sliding in the transversal or longitudinal directions due to weak connections between girder and bearings. Lessons learned from this earthquake are described and recommendations related to the design of curved and skewed bridges, design of bearings and devices to prevent girder collapse, and ductility of bridge piers are presented. Suggestions for future seismic design and retrofitting techniques for bridges in moderate to severe earthquake areas are also proposed.

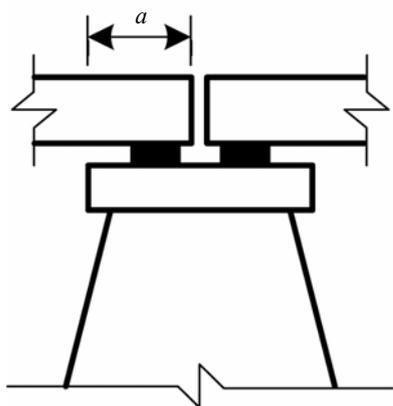
Fig. 2 Minimum seat width in Chinese specifications

According to the Chinese Specification of Earthquake Resistant Design for Highway Engineering (MCPRC, 1990), the minimum seat width a defined as shown in Fig. 2 should satisfy:

Note that in both the China Specifications/Guidelines, the influence of the seismic performance category, substructure height and angle of skew, etc., were not explicitly considered. For bridges with $L = 40$ m, both Eqs. (1) and (2) provide the same minimum seat width of $a = 90$ cm. In fact, the specification in Eq. (2) was given by the 1996 Japanese seismic design specifications of highway bridges revised in 1996 reflecting the destructive damage caused by the 1995 Hyogo-ken Nanbu earthquake (i.e., the Kobe earthquake) (Kawashima, 1997). Note that in addition to providing sufficient seat width and elastic padding between two adjacent girders to prevent failures of this type, it is recommended that strong hinge restraints be

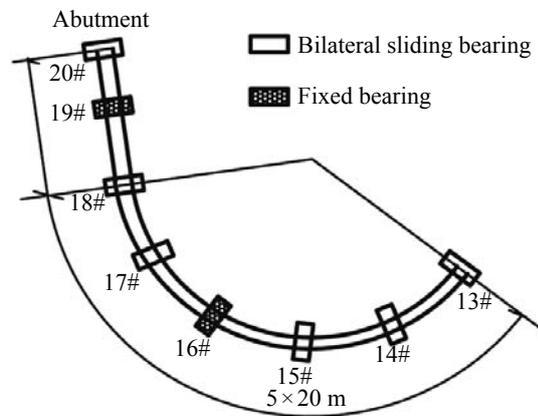
(b) Plane view of Baihua Bridge

bending moment due to the eccentricity of the mass center. It may also exhibit asymmetrical responses as a result of the combined effect of vertical and horizontal ground motions, making curved bridges more vulnerable to extensive damage and possible collapse. Figure 12 shows the collapse of the curved part of the Baihua Bridge. The Baihua Bridge was constructed in 2004 and is located at state route 213, about 2 km from Yingxiu

Fig. 12 Collapse of curved segment of Baihua Bridge (VII/XI)

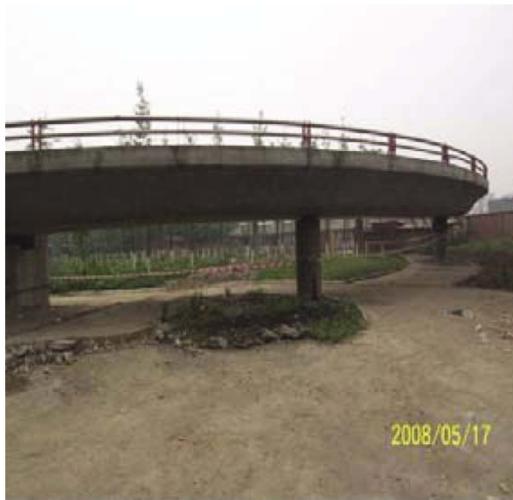
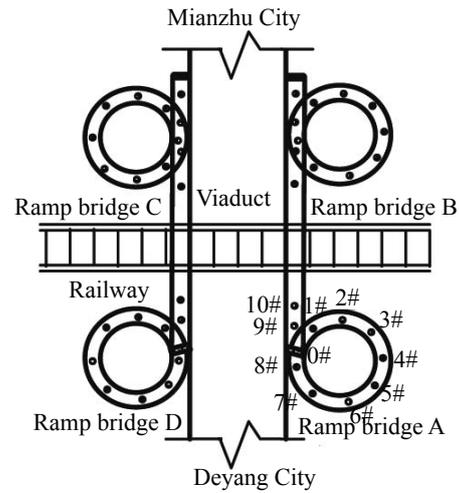
Fig. 13 Ramp bridge of the Huilan interchange (VII/IX)

The ramp bridge of the Huilan interchange was constructed in 2004 and located in Mianzhu City. It consists of a viaduct and four twisted ramp bridges as shown in Fig. 13. The viaduct is approximate 318 m long and 38 m wide. The substructure of the ramp bridges consisted of curved continuous box-girders, and the planar projection was circular. The radius of the ramp bridges was about 20 m, the height of the box-girder was 1.4 m, and the top and bottom widths of the box-girder were about 4 m and 2.2 m, respectively. The eight circular pier columns were circumferentially distributed evenly and the pier columns were about 1.8 m to 7.2 m high.

Some piers were fixed at their top to the box girder, i.e., the curved ramp, while others were connected to the superstructure via rubber bearings. The tops of the fixed piers were damaged during the earthquake since they experienced larger earthquake loads. The failures of 2# and 4# piers are shown in Fig.14, where the diameter of the pier columns was 800 mm, the circumference of the pier columns was reinforced with 20Φ25 rebar, and the ratio of longitudinal reinforcement was 1.95%. The hoop rebar distance of the pier column was about 100 mm to
